**Depth of Cover Survey and Inspection**

**Bridger Pipeline**

**Yellowstone River  
12" Line  
Dawson County, MT**

**DATE OF INSPECTION:  
April 18, 2012**

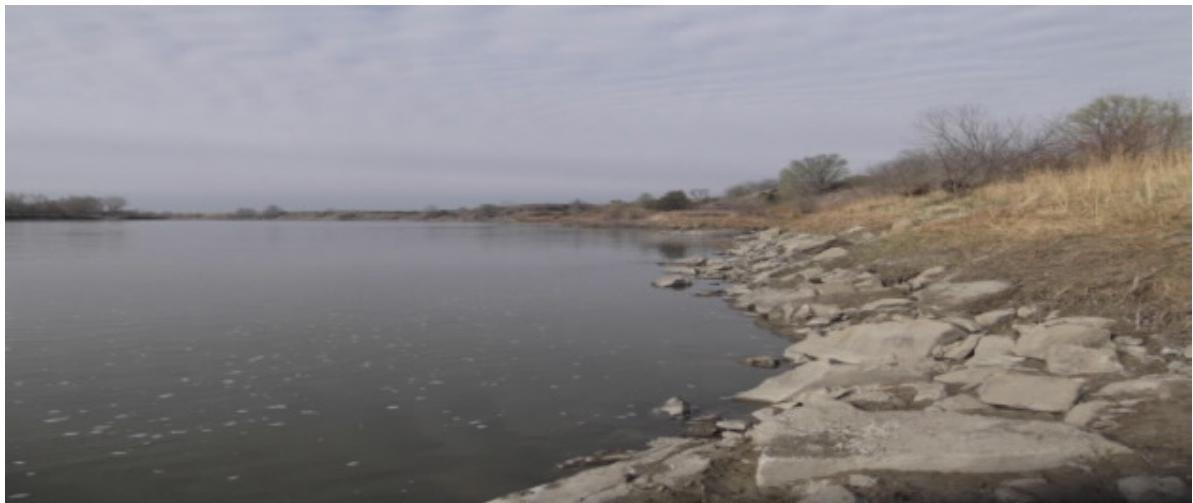
North Bank  
Looking  
Upstream

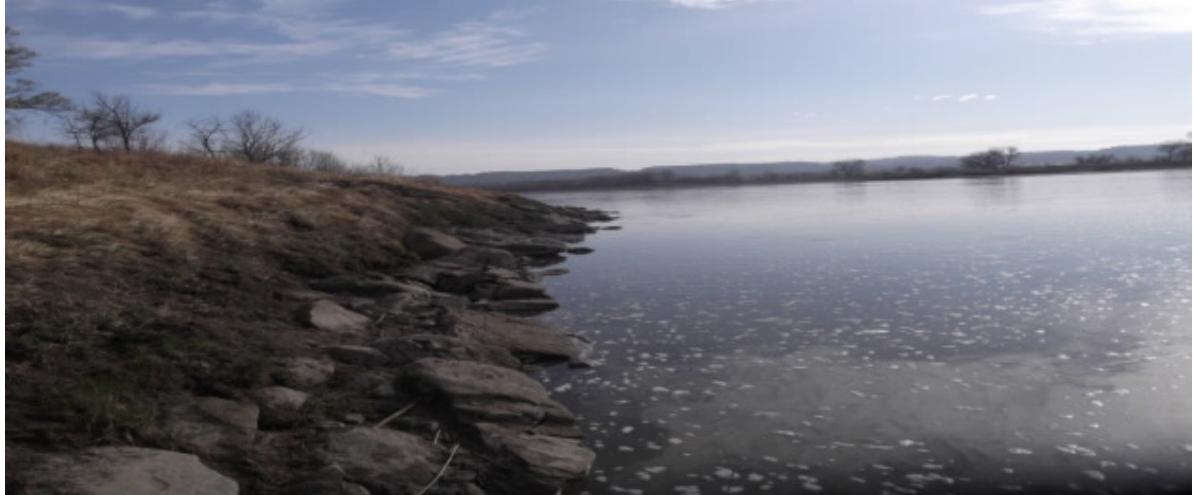
North Bank  
Looking  
Downstream

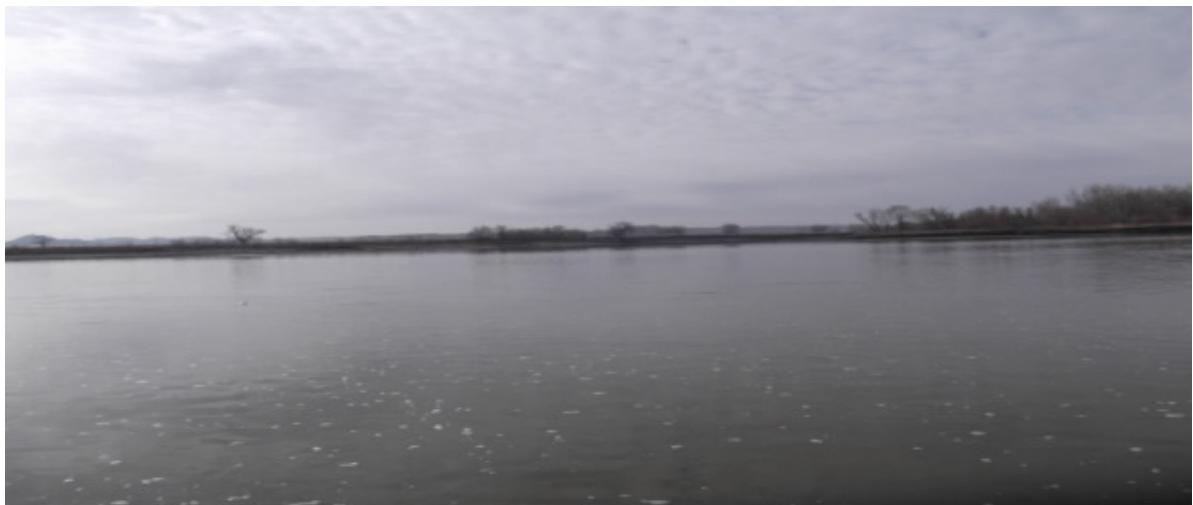
North Bank  
Looking to  
South Bank

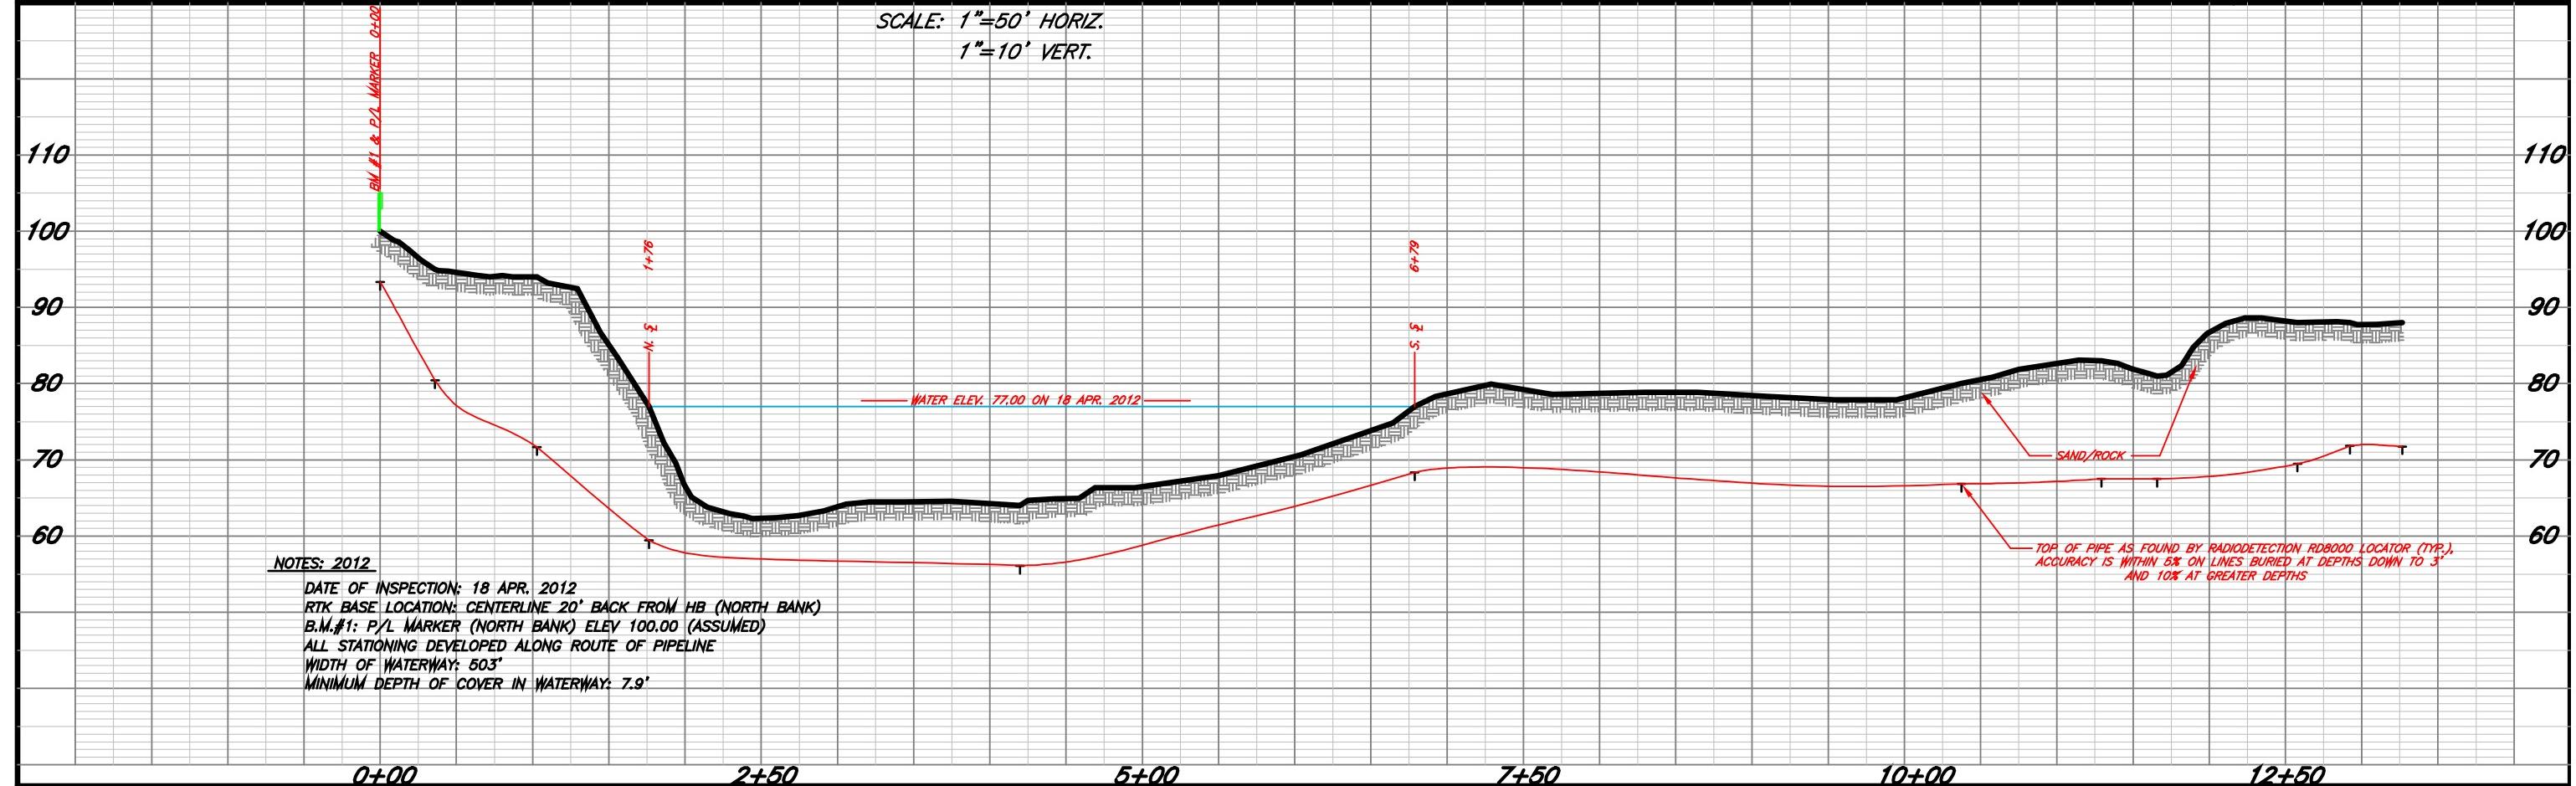
**PROFILE 12" LINE**

Minimum Depth of Cover at time of Survey: 7.9'
